Landslide Dam Failures: Historical Examples and Modelling Considerations

Krey Price

Director, Surface Water Solutions, Kelmscott, Western Australia

September 1, 2017

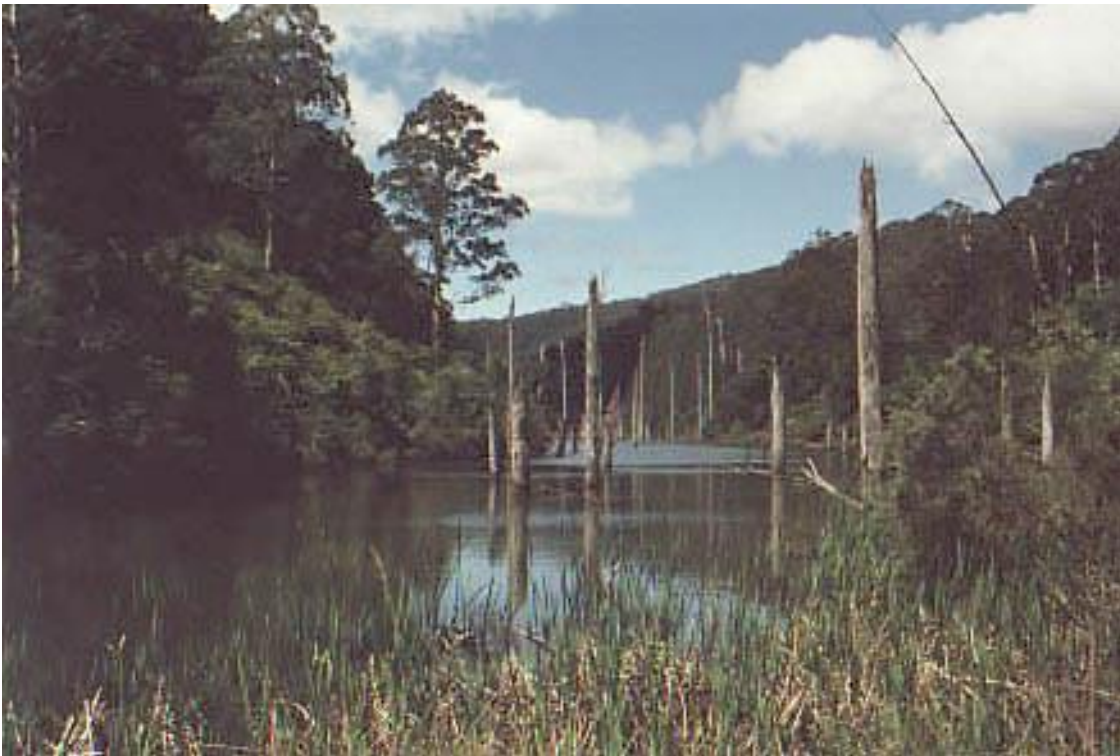
Figure 1. Lake Elizabeth: Landslide-formed lake on the East Barwon River (Source: Dept. of Parks)

The East Branch of Australia's Barwon River was blocked by a landslide in Victoria in 1952. The top 26 metres of the landslide dam breached after heavy rains the following year. Fortunately, the downstream flood wave did not result in any fatalities, and the remaining material is now considered to be stable. The water body that has formed behind the remaining embankment is now known as Lake Elizabeth (Figure 1), which serves as a recreational area and a destination for local eco-tours. While Lake Elizabeth is a benign example of the potential for the formation and failure of landslide dams in Australia, other worldwide examples show tragic loss of life and substantial impacts to property and the environment in similar situations.

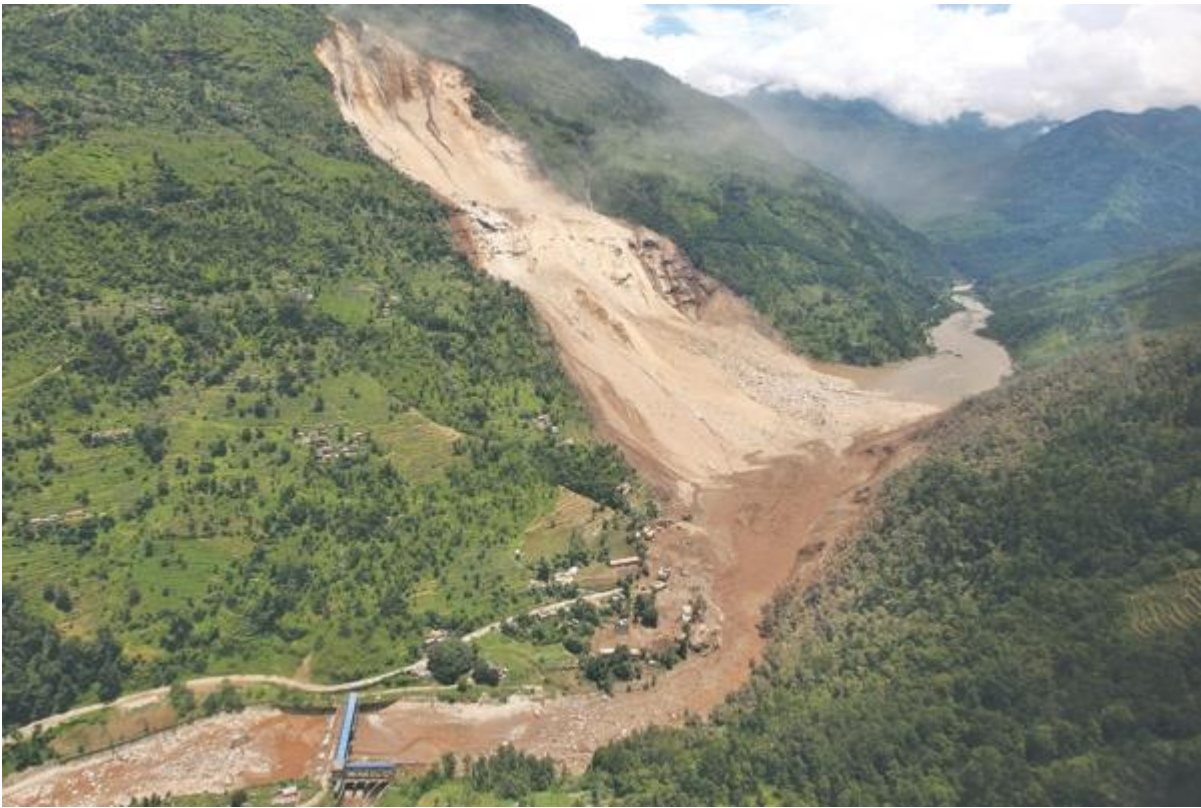
Figure 2. Landslide dam formed in 2014 on Nepal's Sunkoshi River (Source: Kathmandu Post)

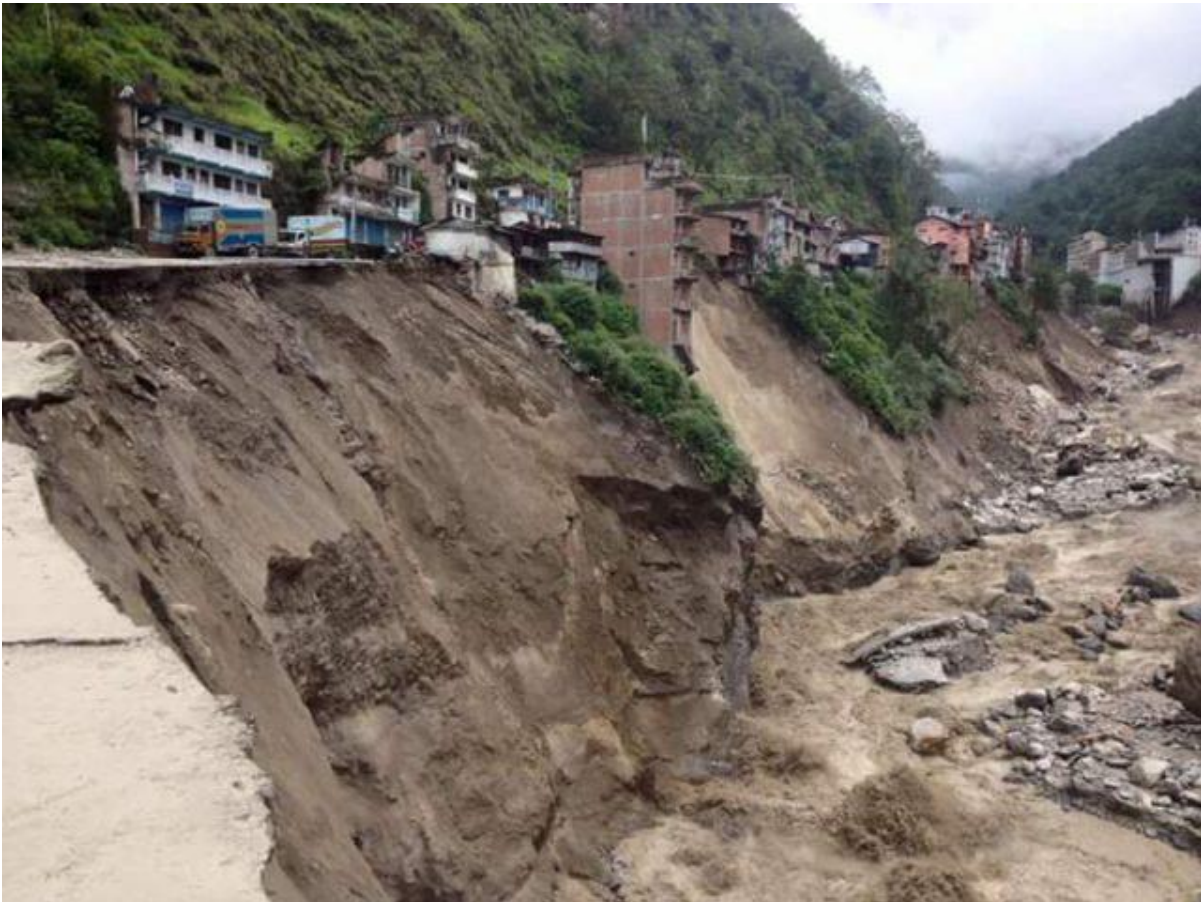
Figure 3. Downstream impacts of 2016 landslide dam failure on Tibet's Bhoté Kishi River (Himalayan Times)

The consequences of dam failure – for both natural and constructed dams – are not just measured in terms of immediate fatalities, but also in the resulting displacement of populations, economic impacts, and outbreaks of famine and disease that have historically pushed the number of actual dam failure casualties into the millions. In any case, the consequences can be massive in scale. Figure 2 shows a recent example of a lake forming behind a landslide in Nepal. Figure 3 shows an example of the impacts of a downstream flood wave after the recent failure of a landslide dam in Tibet.

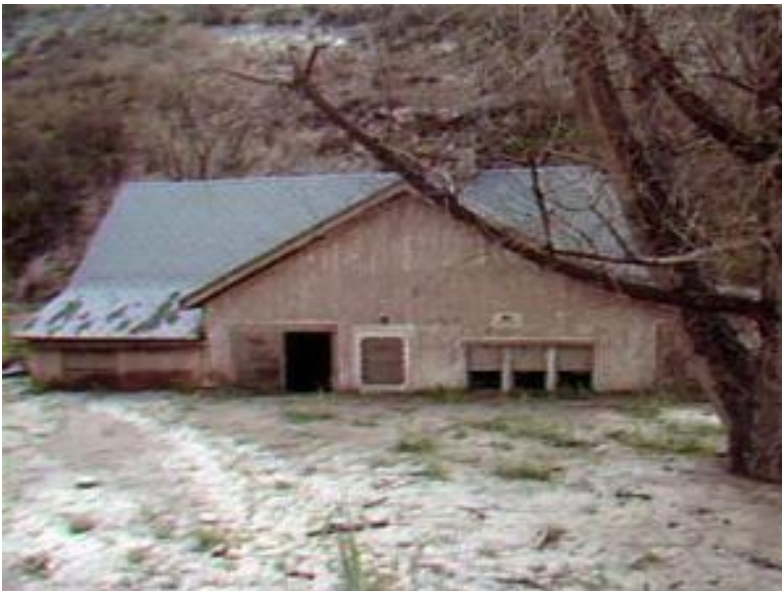
Figure 4. Residence in the former town of Thistle, Utah, inundated by a landslide dam (Source: USGS)

As another example, when a landslide blocked the Spanish Fork River in the United States in 1983, the town of Thistle, Utah was inundated by the reservoir that formed upstream of the dam (Figure 4). A tunnel was eventually excavated through the hillside to prevent overtopping and failure of the landslide dam, but water levels and siltation in the new lake turned Thistle into a ghost town.

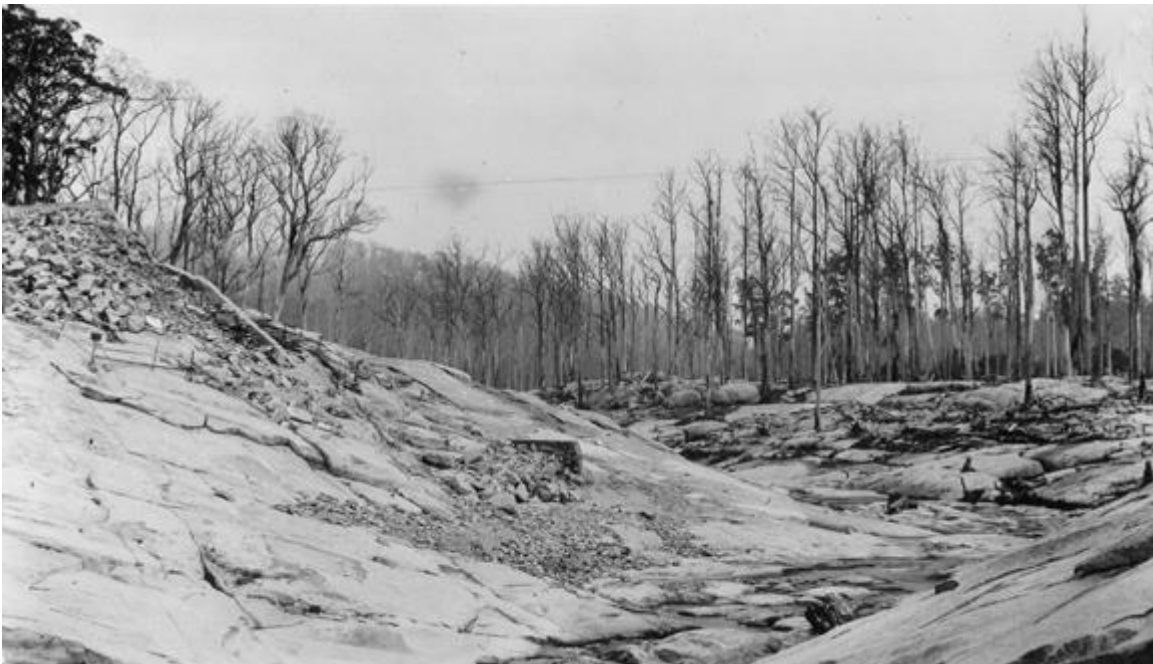
Figure 5. Remains of the Cascade Dam, with ground stripped to bed rock by the flood wave (Source: E. Barsham)

The most prominent Australian dam failure occurred in Tasmania in 1929. The Briseis Tin Company had constructed the Cascade Dam to provide water supply for their operations. After 500 mm of rain fell in one day, the dam overtopped and failed (Figure 5) unleashing a 6-metre high wall of water that carved a 30-metre deep channel in the downstream valley and carried floodwater and debris through the town of Derby. Fourteen lives were lost in the flood.

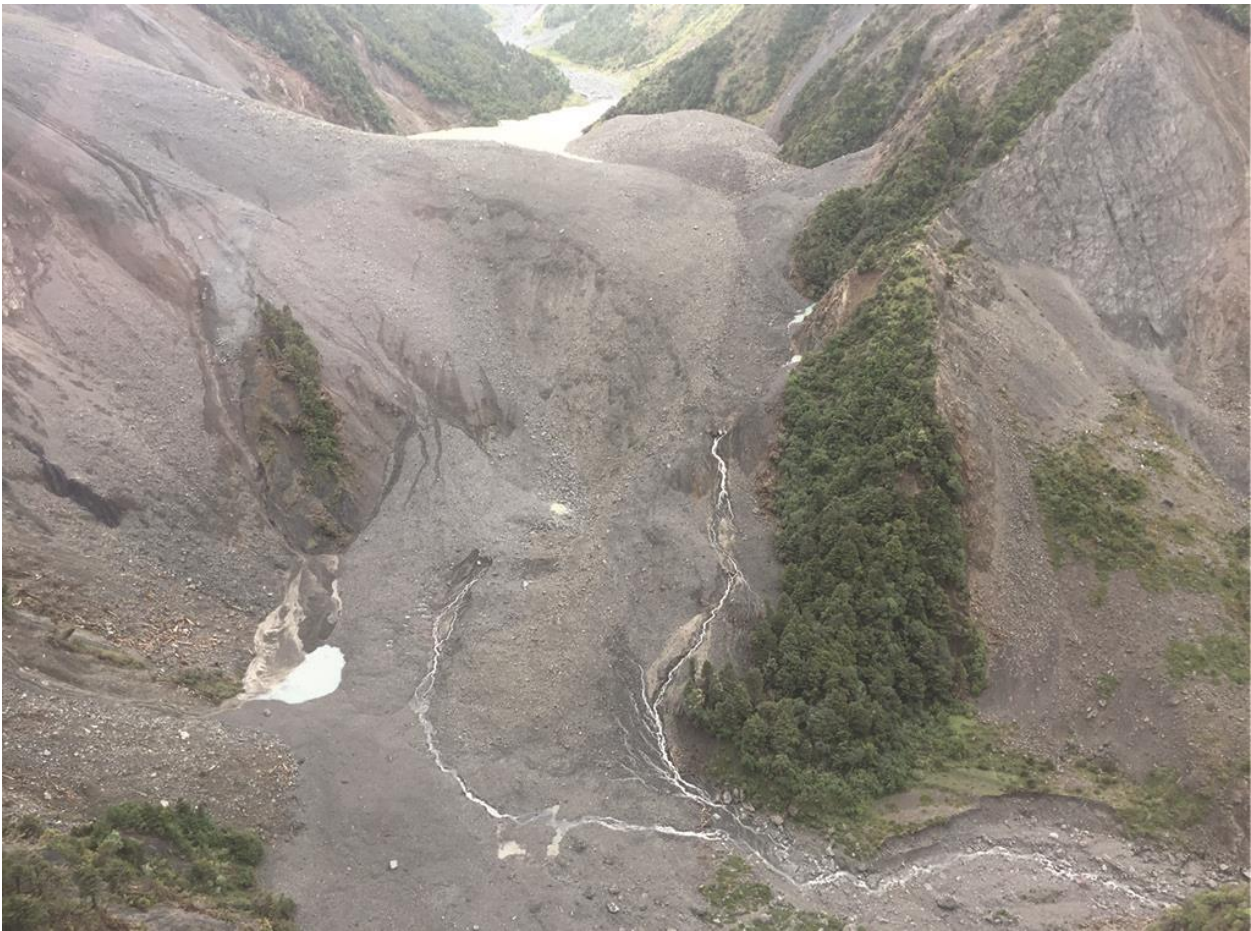
Figure 8. Hapuku River landslide dam, 2016 (Source: GNS Science)

Figure 6 shows the location of mapped landslides generated by the Kaikoura 2016 earthquake. Figure 7 shows the largest of the observed landslide dams, which blocked the Hapuku River. Figure 8 shows the landslide immediately following the 2016 earthquake while Figure 9 shows the landslide dam breach formation after overtopping in April 2017.

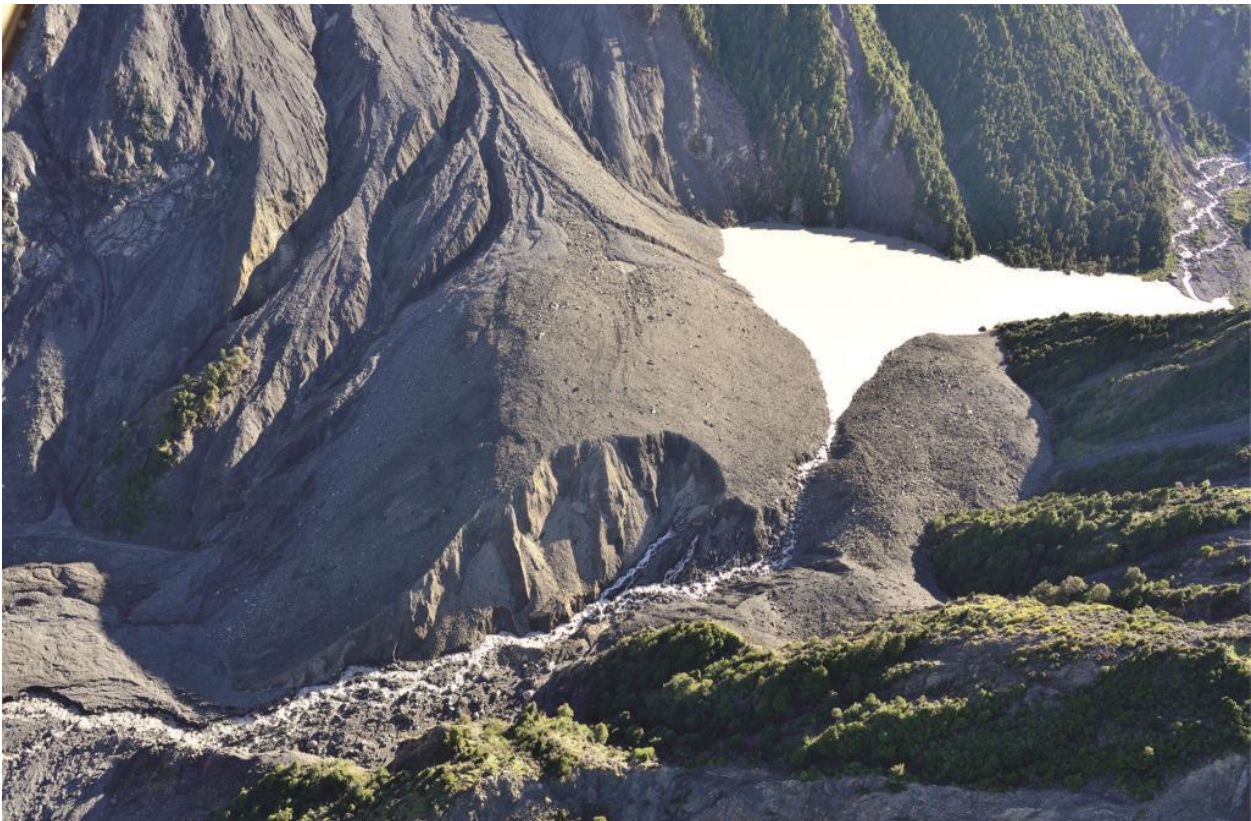
Figure 9. Breach formation from overtopping of the Hapuku River landslide dam, 2017 (Source: GNS Science)
